July 30, 2012

Subject: **Limited Asbestos Survey – Indoor Shooting Range Renovation Project, Houston Police Academy, 17000 Aldine Westfield Road, Houston, Texas 77073**

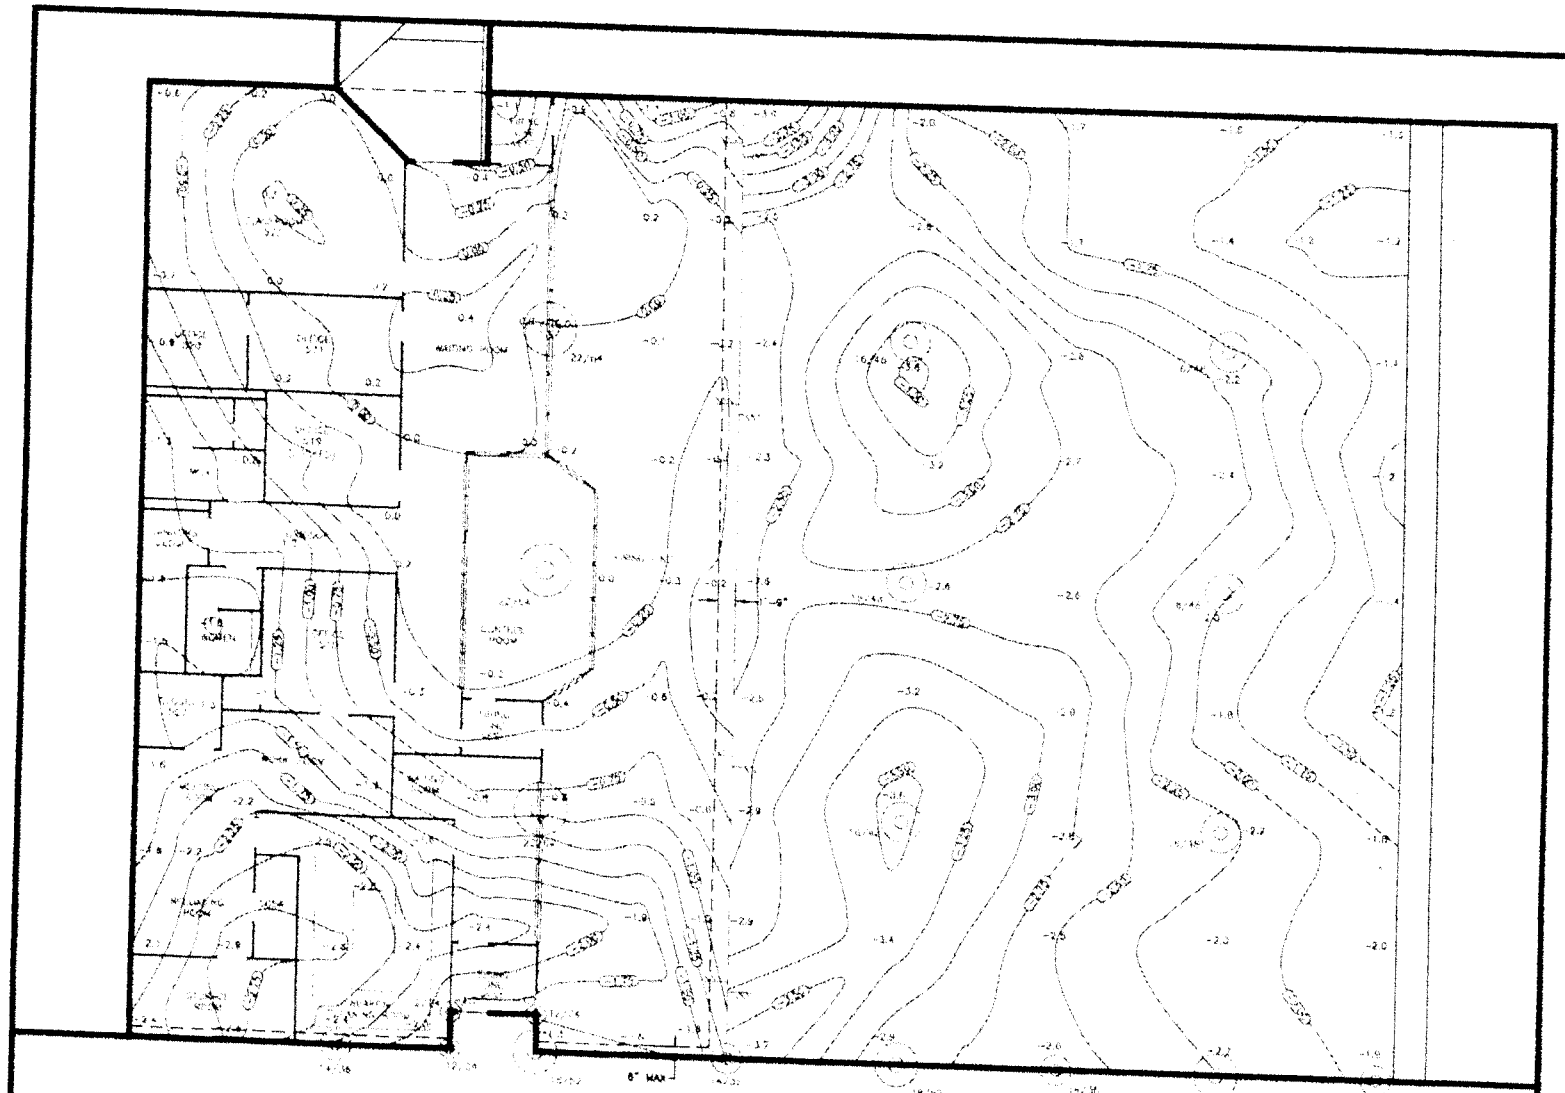
S1.0

EXISTING FOUNDATION SLAB TOPOGRAPHY

EXISTING CONDITIONS

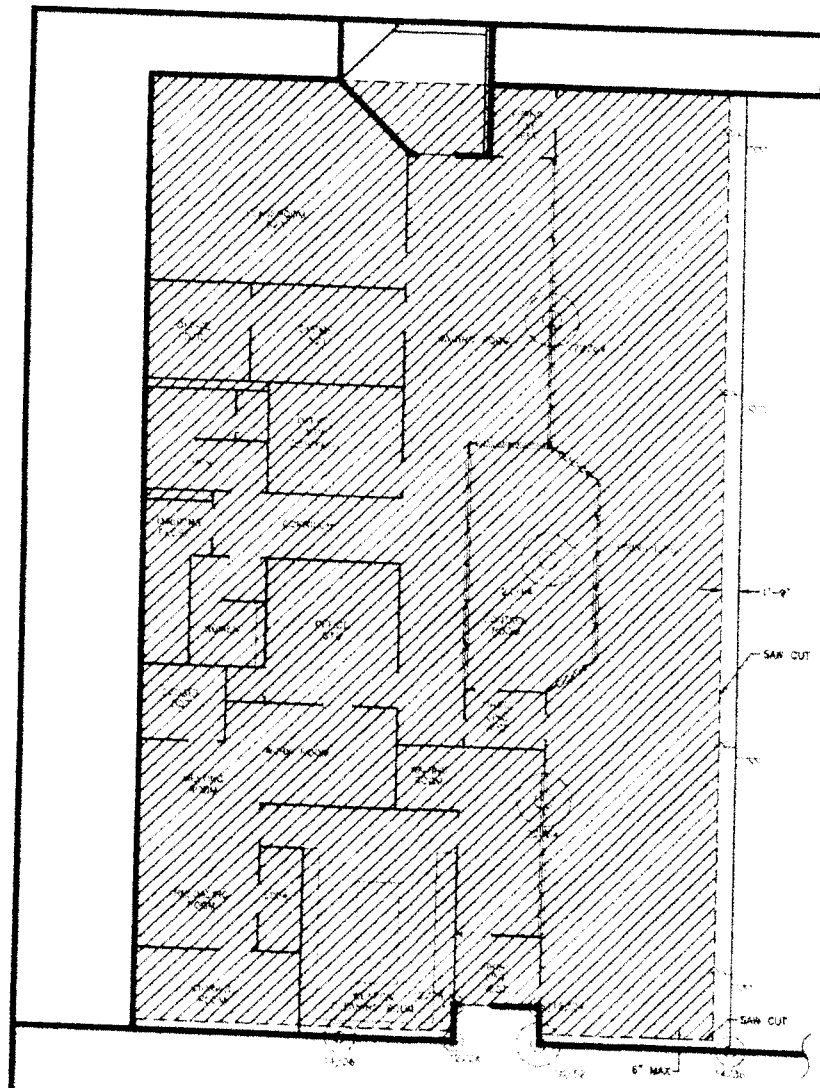
S2.0

DEMOLISH WALLS AND CONCRETE FLOOR SLAB.

NOTE: EXISTING #5 DOWELS @ 80" O.C. ALONG PERIMETER WALLS TO BE CONFIRMED AND SALVAGED BY CONTRACTOR. CONTRACTOR TO NOTIFY ENGINEER OF ANY MISSING OR DAMAGED DOWELS.

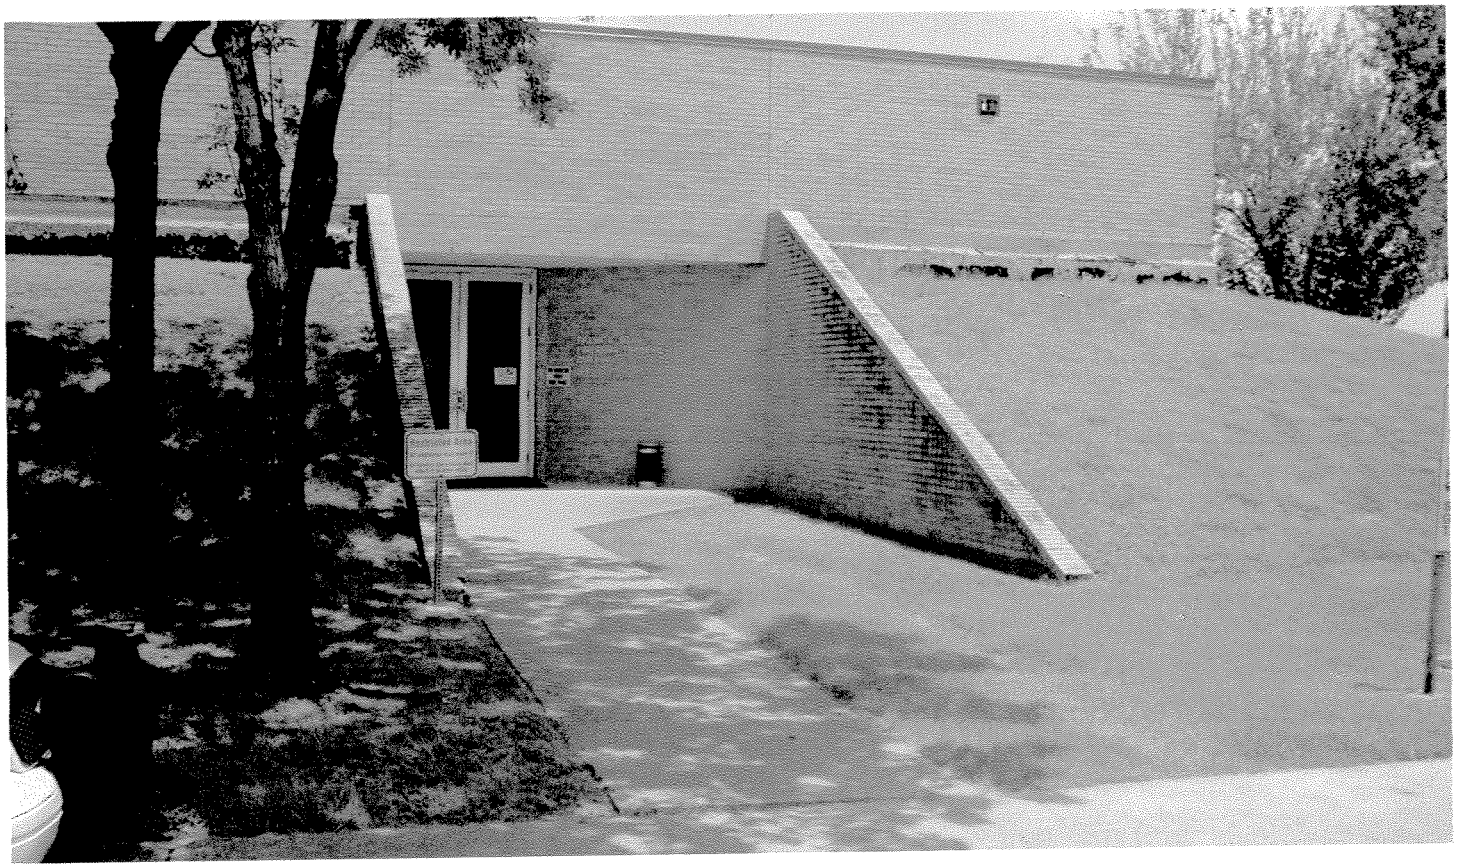
Indoor Shooting Range Entry, Houston Police Academy, 17000 Aldine Westfield Road, Houston, Texas 77073

Indoor Shoot Range Building, Houston Police Academy, 17000 Aldine Westfield Road, Houston, Texas 77073
